MICRO-DAM RESERVOIR LEAKAGE AND
HYDROGEOLOGICAL SETTING IN TIGRAY,
NORTHERN ETHIOPIA

**Thesis submitted in fulfillment of the requirements for the award of
Degree of Doctor (PhD) in Sciences: GEOLOGY**

The subject of this PhD dissertation is to evaluate the MDRs in Tigray in the context of their engineering and geo-hydrological problems in general and to study in detail the mechanisms and causes of leakage on selected MDRs. From an inventory of 92 MDRs during the period of field survey (2012/13), 56 (61%) have siltation problem, 49 (53%) leakage, 23 (25%) structural dam body damage, 21 (23%) inflow problem and 19 (21%) have spillway route erosion. The main problems highlighted, siltation and leakage, are found to be highly linked to geological factors. These problems are found to be very high in MDRs located in sedimentary rocks. Siltation is found to be more significant in areas where shale is the dominant rock type; on the other hand leakage is more common in areas where limestone predominates.

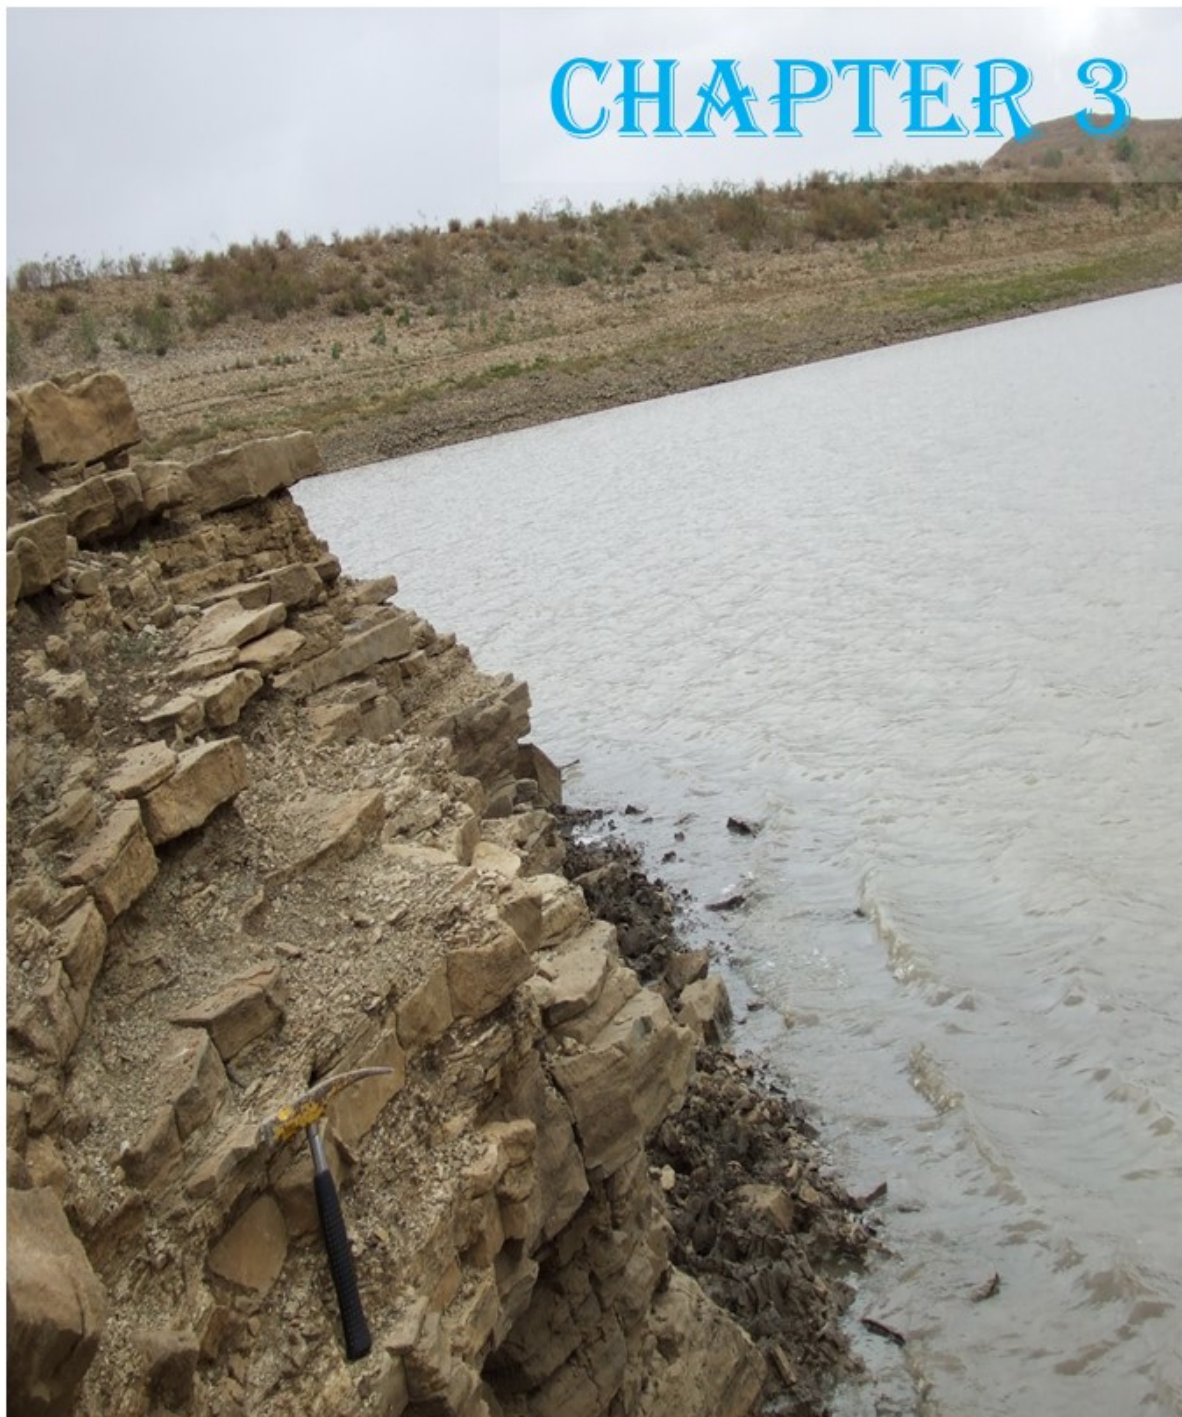
A close view of Hashenge MDR (part of the right abutment/flank, limestone-shale-marl intercalation unit, and the dam body) ©2010 Gebremedhin Berhane

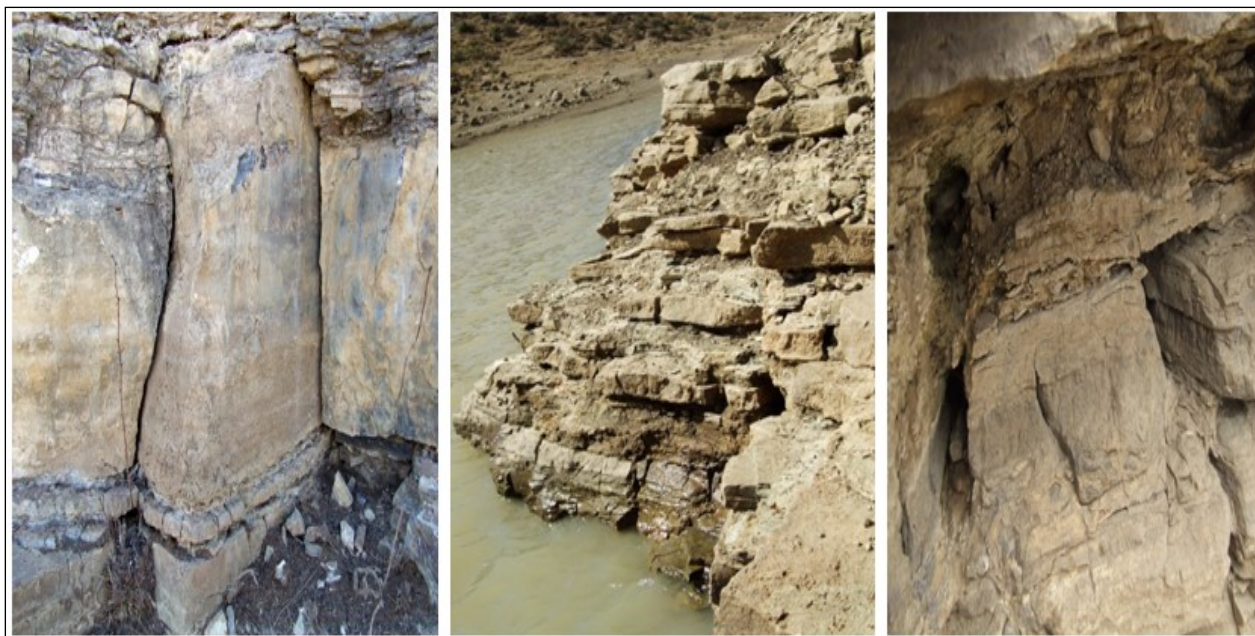
Figure 3.7. Field photograph showing bedding and tectonic joints and intersection of different sets of discontinuities in limestone-shale-marl intercalation.

limestone-shale-marl intercalation, in which no defined pattern is observed (Fig. 3.7). Discontinuities are widely spaced and tight and the surfaces of the joints are slightly rough, but dominantly smooth and they were found to be dry.

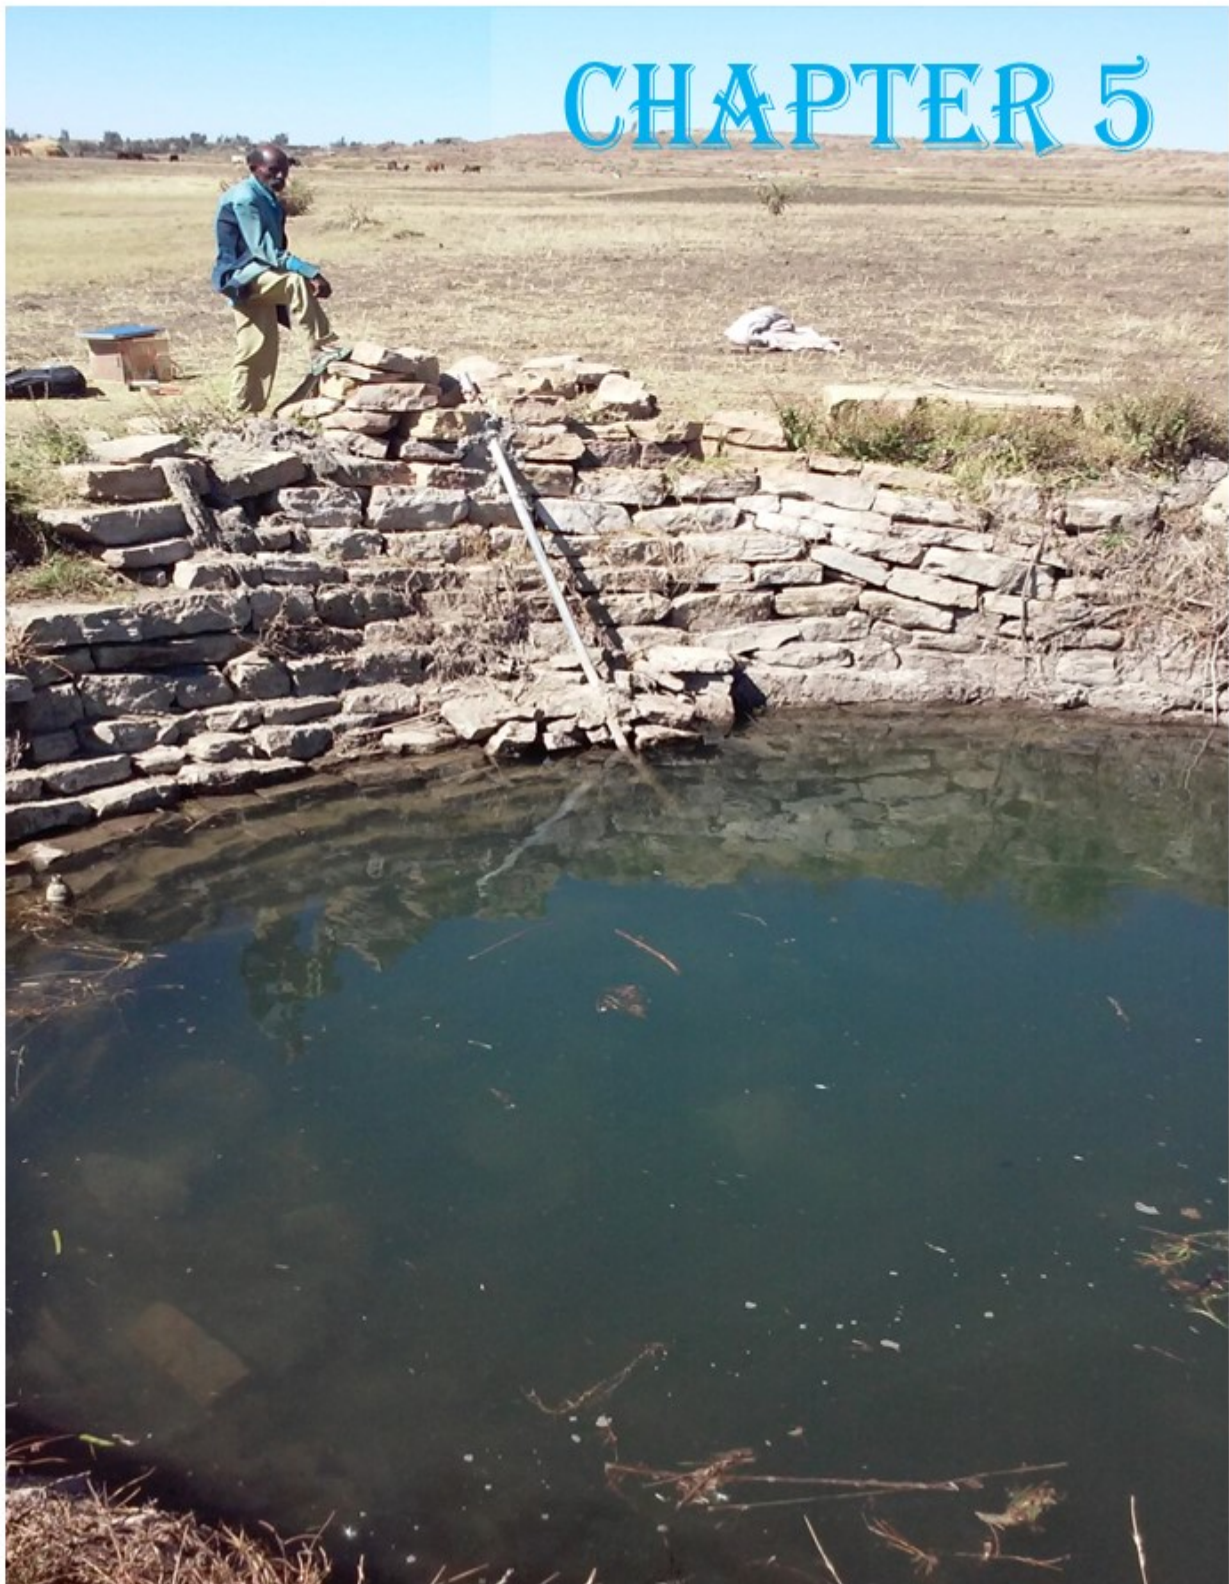
Shallow hand dug well (about 4m deep) with diver installed inside a pipe at downstream of Arato MDR ©2015 Gebremedhin Berhane.

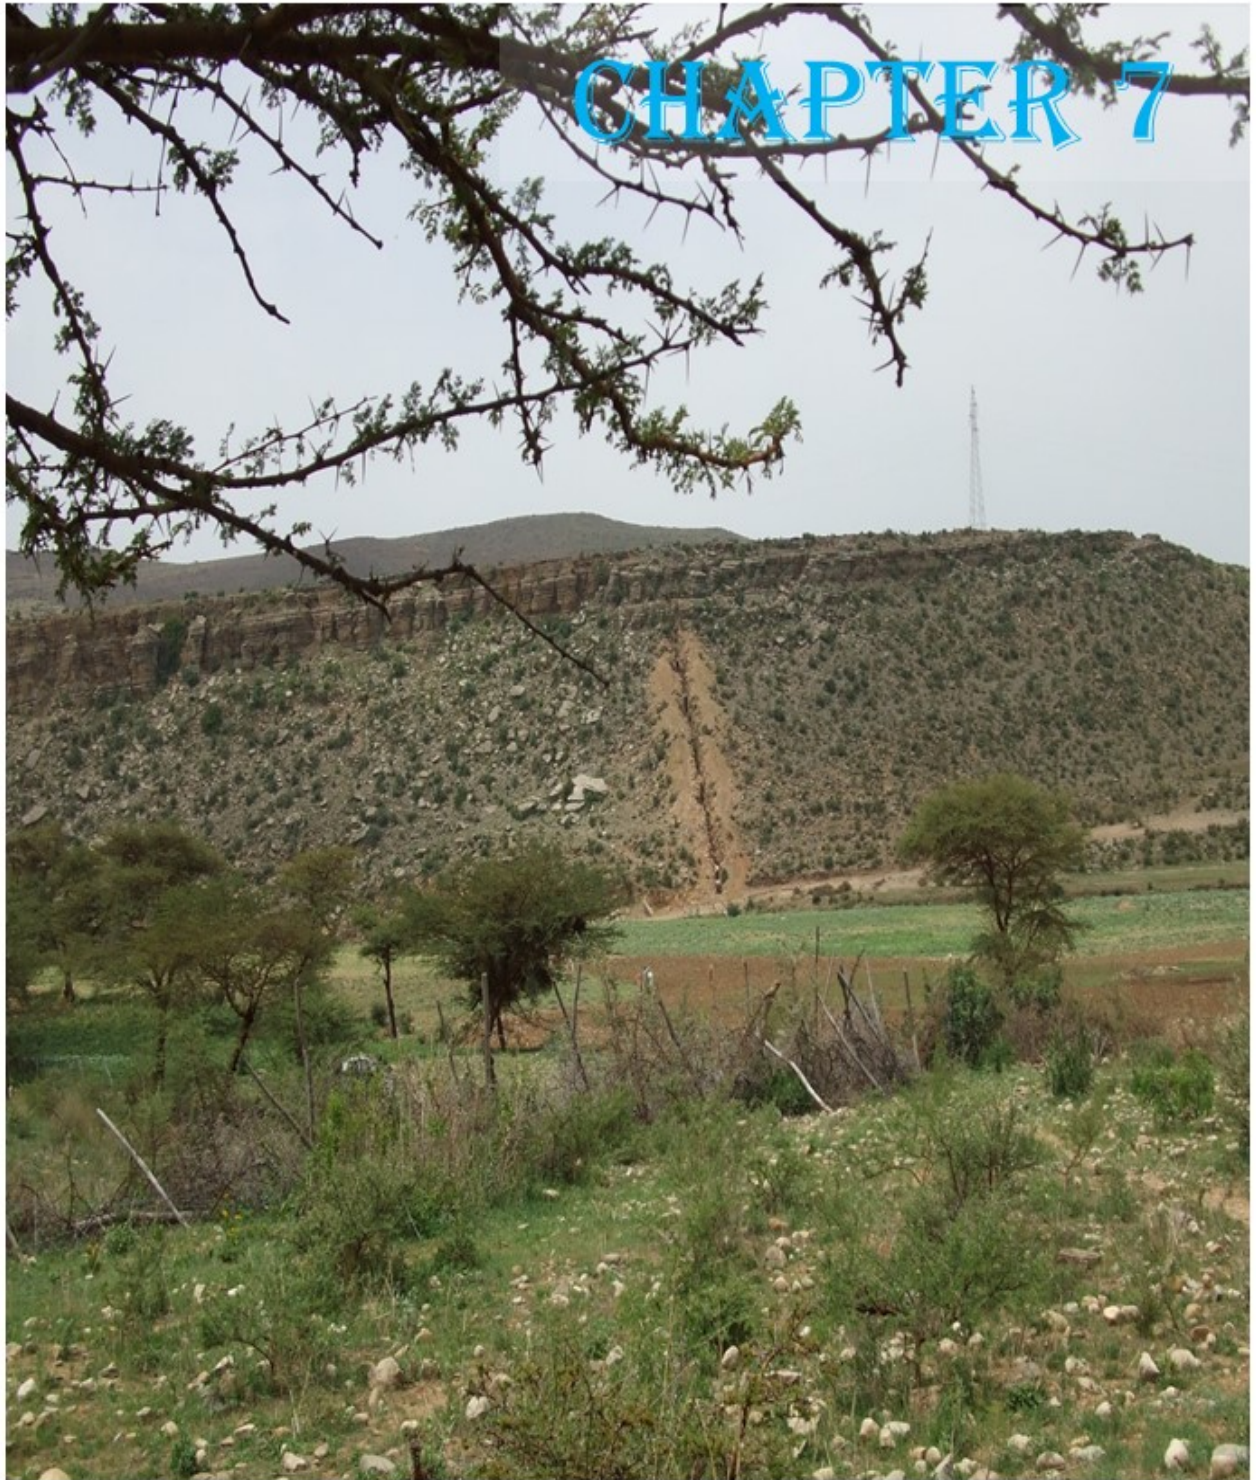
Partial view of Geba proposed dam site (from NNW to SSE direction) a trench on the left abutment is shown near the center of the photograph. The author has participated in this project as senior engineering geologist during drilling and pressure test operations ©2009 Gebremedhin Berhane.

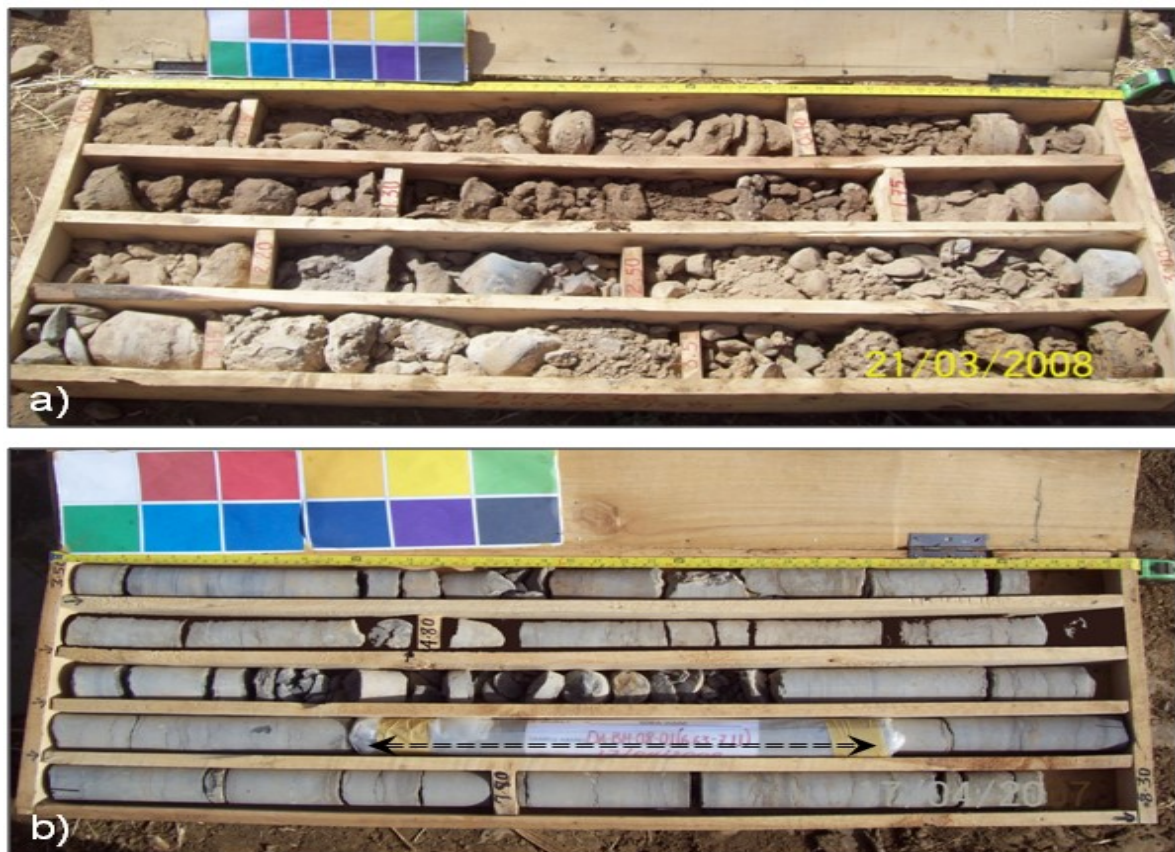
Figure 7.5. Selected core from Geba dam site. a) Alluvial deposit with gravels and boulders (BH-2, depth interval: 0.00–4.00 m), b) limestone-shale intercalation (BH-02, depth interval: 3.50–8.30 m).

The central river valley is covered by alluvial deposits (gravel-sand mixtures and clayey sand, Figs. 7.3, 7.5a, 7.6) with a thickness of up to 20 m, underlain by alternating fractured and bedded limestone-shale intercalations (Figs. 7.5b, 7.6). These are extremely variable in thickness and character and extend up to more than 120 m below ground level. The geological sequences of the left and right abutments are similar to those of the central foundation, except that there is no alluvial overburden in the central area although in places thin layers of colluvial deposits and thick limestone overlie the limestone-shale intercalation unit (Fig. 7.5).

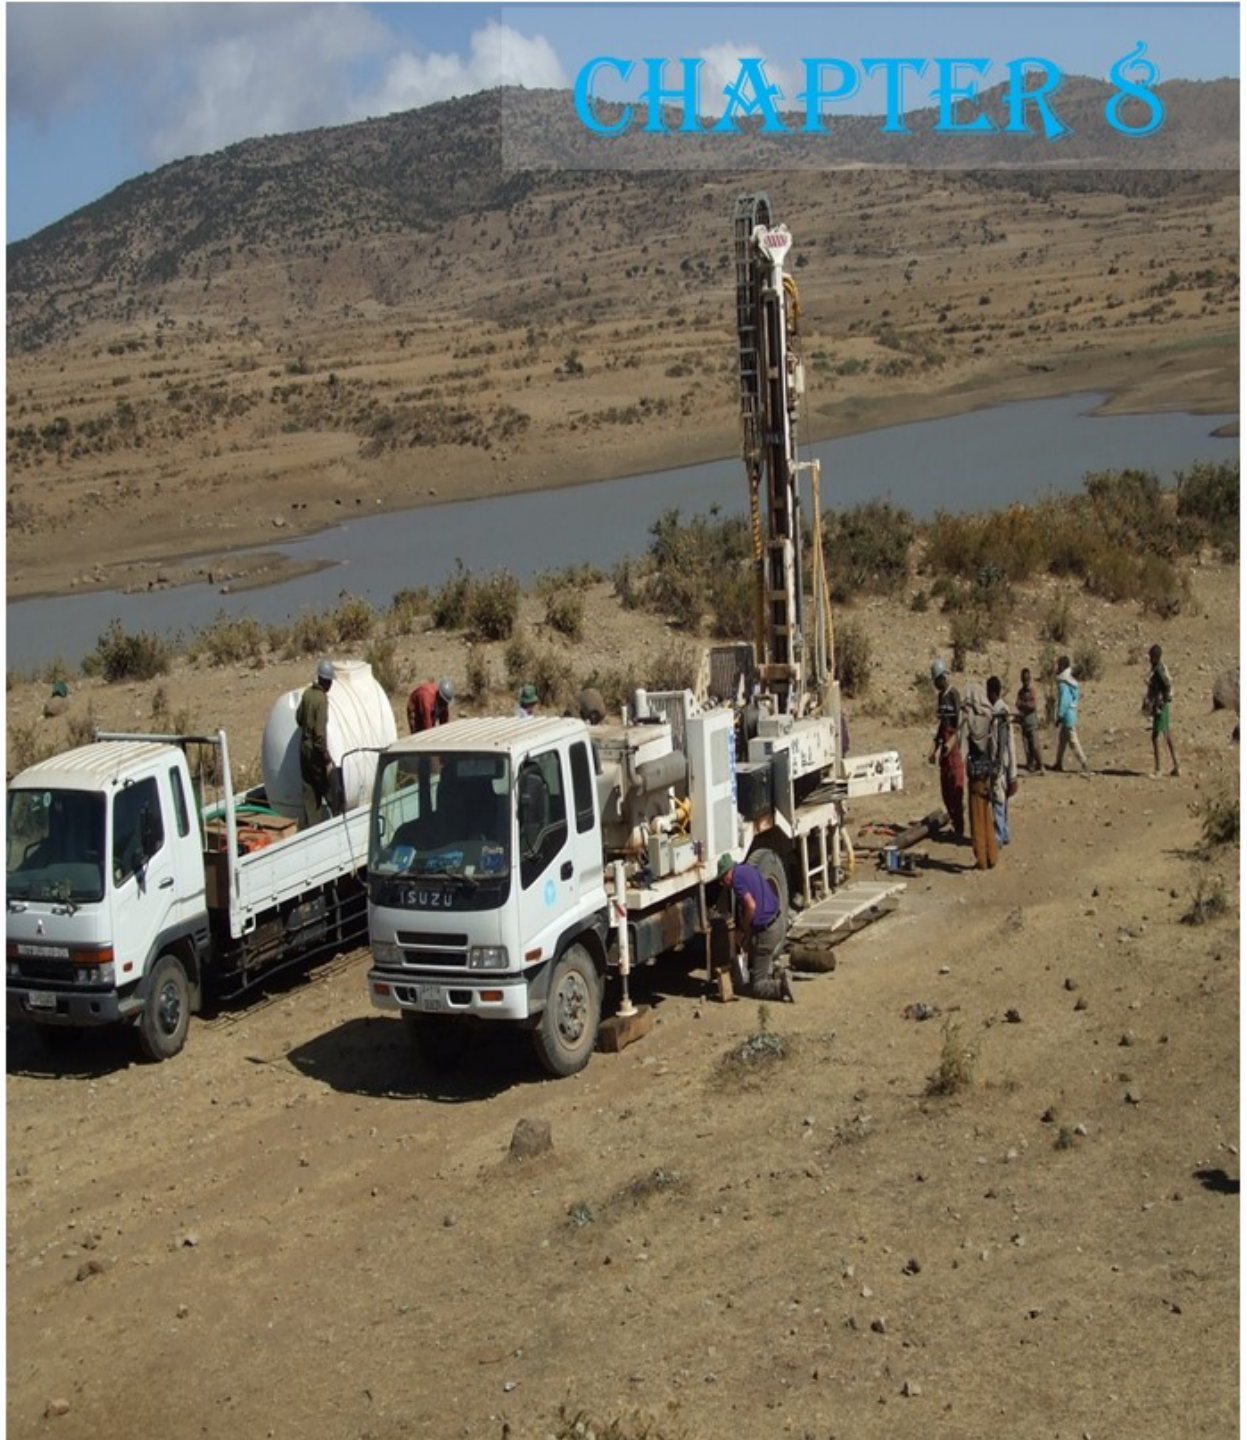
*Geotechnical drilling operation at Hashenge MDR (at left abutment). Delta 250 Drilling Rig
©2009 Gebremedhin Berhane.*
